• **Timber Frame Withstands Fire**

But Timber Hangar Frame Stands Up

T. K. May
Director of Technical Service
West Coast Lumbermen's Association
Portland, Oregon

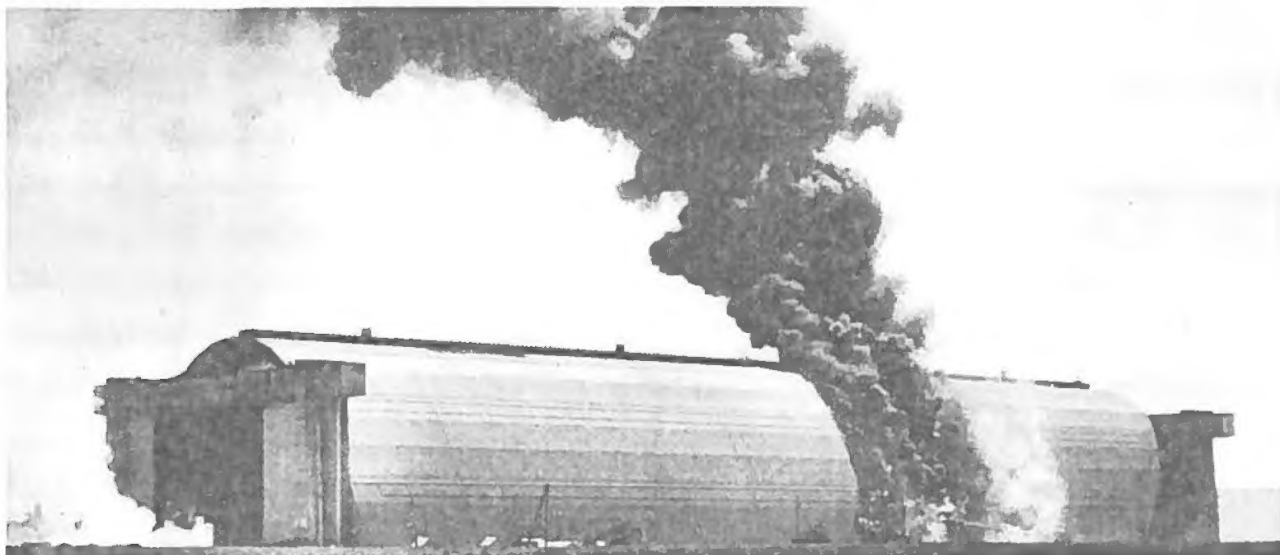
Fire . . .

Roofing material burned when residuals in plywood manufacturing facilities, now occupying former World War II blimp hangar at Tillamook, Ore., burst into flames
